**Flood Control Project Maintenance  
Levee Inspections**

**Spring 2010 Levee Inspection Results**

**Madera County FCWCA**

Waterway		Bank	Unit Miles
Unit No. 01 Ash Slough		Right	2.41

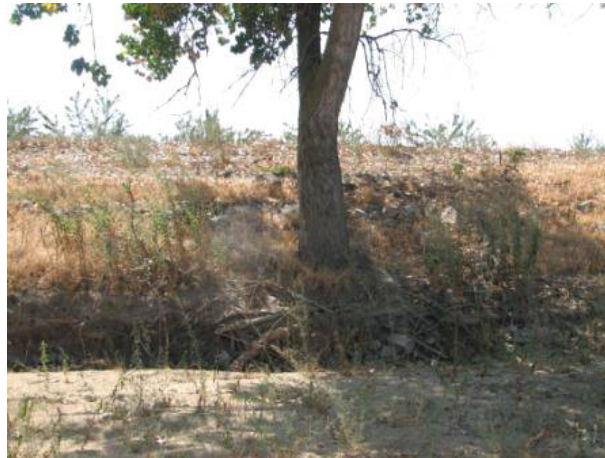
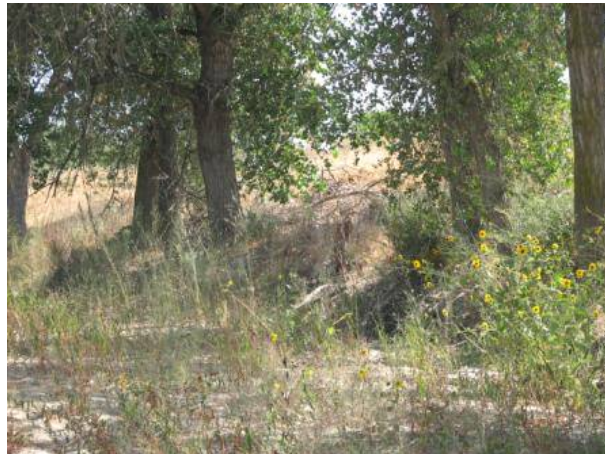
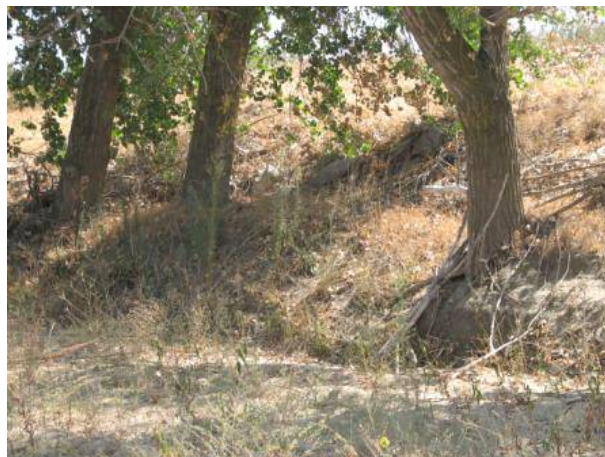
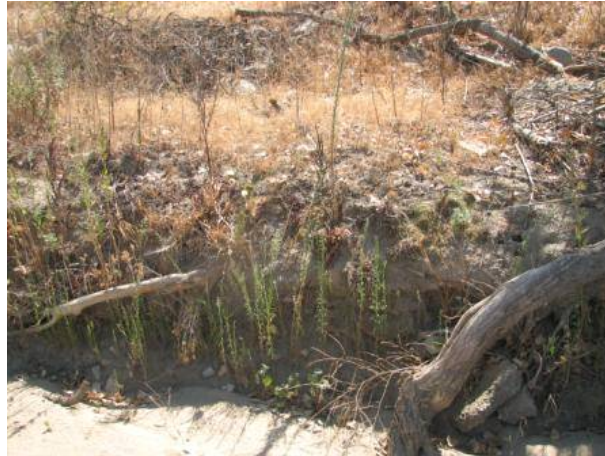
Levee Mile Report Line	10
Start Levee Mile	1.11
End Levee Mile	1.20
Location	Water Side
Category	Supplemental
Item	DWR Erosion Survey
2009: Site recommended as local maintenance issue, per Critical Levee Repair Office, Critical Erosion Sites Evaluation 2008 Report; previously rated "M" [2009 SiteID:NA0011U1RM2.57]	
SJR2009_RM2.57A.JPG

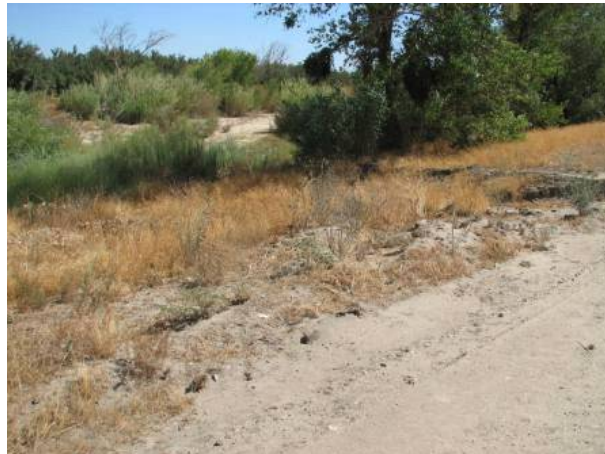
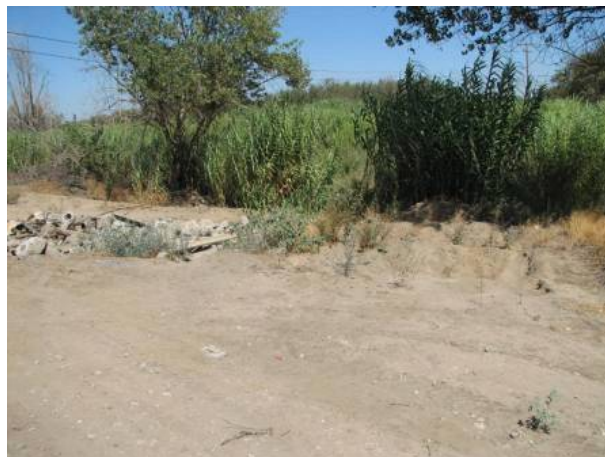
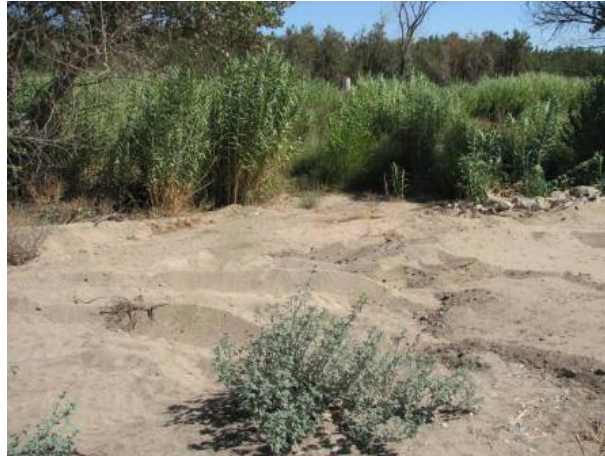
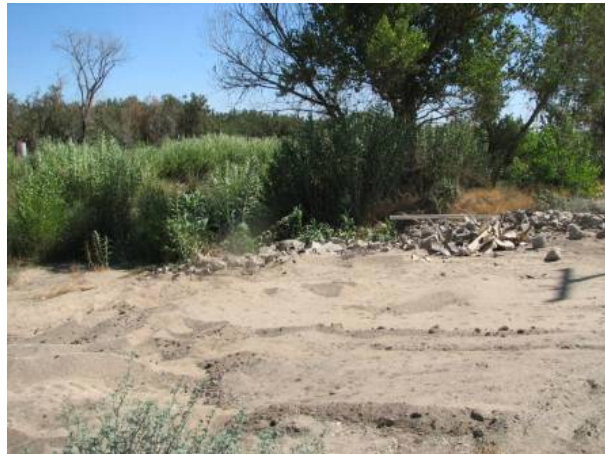
13	2.37	2.39	Supplemental	DWR Erosion Survey	WS	M	Inspector Comments: 2009: Site recommended as local maintenance issue, per CLRO CES Evaluation 2008 Report; previously rated "M" [2009 SiteID:NA0011U1RM3.8]	37.068570 ° -120.398620 °	37.068570 ° -120.398620 °	2 Y

Levee Mile Report Line	13
Start Levee Mile	2.37
End Levee Mile	2.39
Location	Water Side
Category	Supplemental
Item	DWR Erosion Survey
2009: Site recommended as local maintenance issue, per CLRO CES Evaluation 2008 Report; previously rated "M" [2009 SiteID:NA0011U1RM3.8]	
SJR2009_S1 LM2.38 082508c.JPG

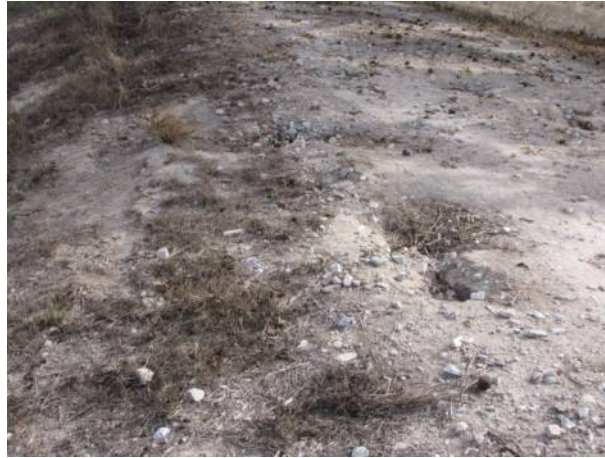
phillips\_s\_20100316\_001.jpg

Levee Mile Report Line	10
Start Levee Mile	1.50
End Levee Mile	1.53
Location	Crown
Category	Earthen Levee
Item	Animal Control

There are several rodent holes in the shoulder and crown of the road way.

11	1.50	1.53	Earthen Levee	Animal Control	WS	M	Exterminate rodents and backfill and compact or grout burrows.	36.996557 ° -120.347102 °	36.996583 ° -120.346678 °	9

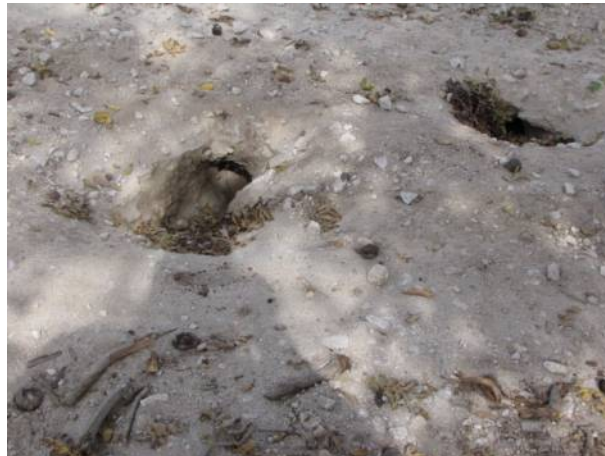
phillips\_s\_20100316\_002.jpg

Levee Mile Report Line	10
Start Levee Mile	1.50
End Levee Mile	1.53
Location	Crown
Category	Earthen Levee
Item	Animal Control

This photo show holes in crown and shoulder.
